TRANSPORTATION SAFETY

REFLEXIONS

Issue 19 – November 2003

Vandalized Switch

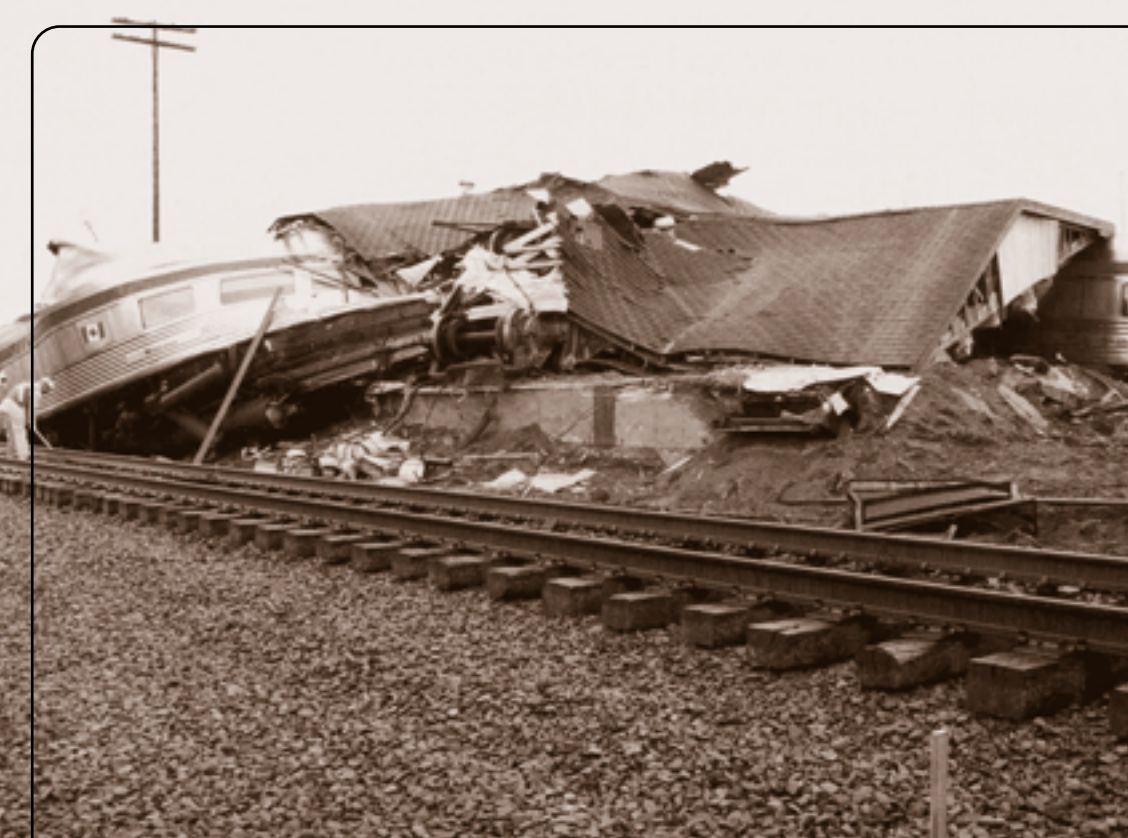
Damage to diner car and farm supply building. Note foundation wall and roof of building in centre of photograph.

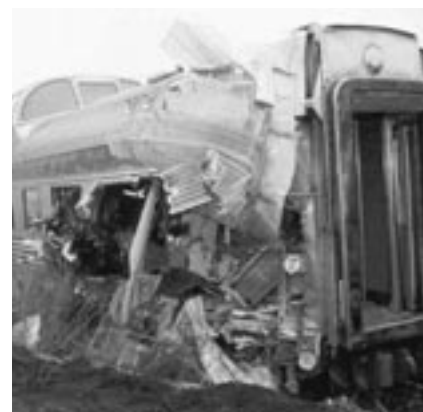
Damage to Skyline car due to contact with the foundation wall of the farm supply building.

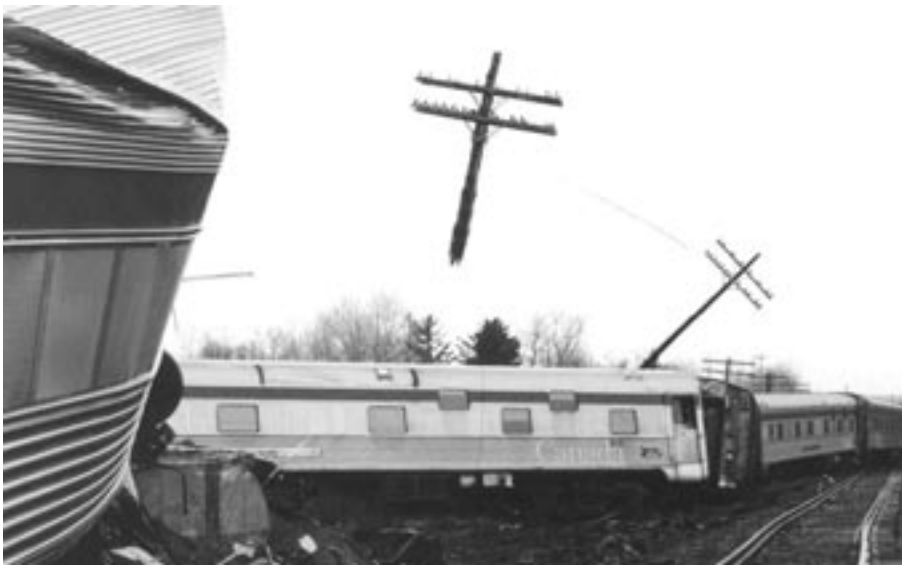
View from diner car looking toward rear of train.

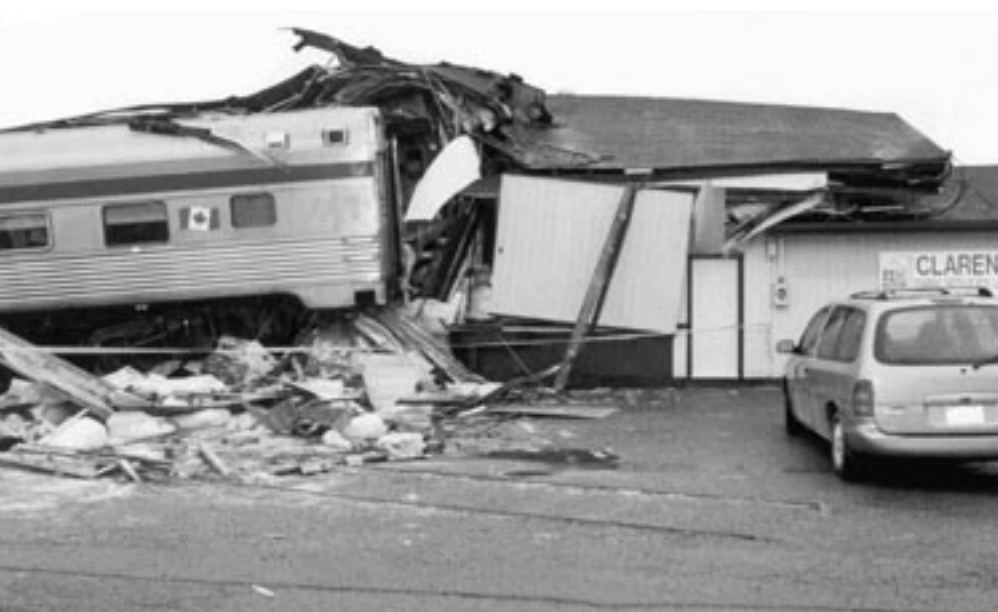
Sleeper car and farm supply building.

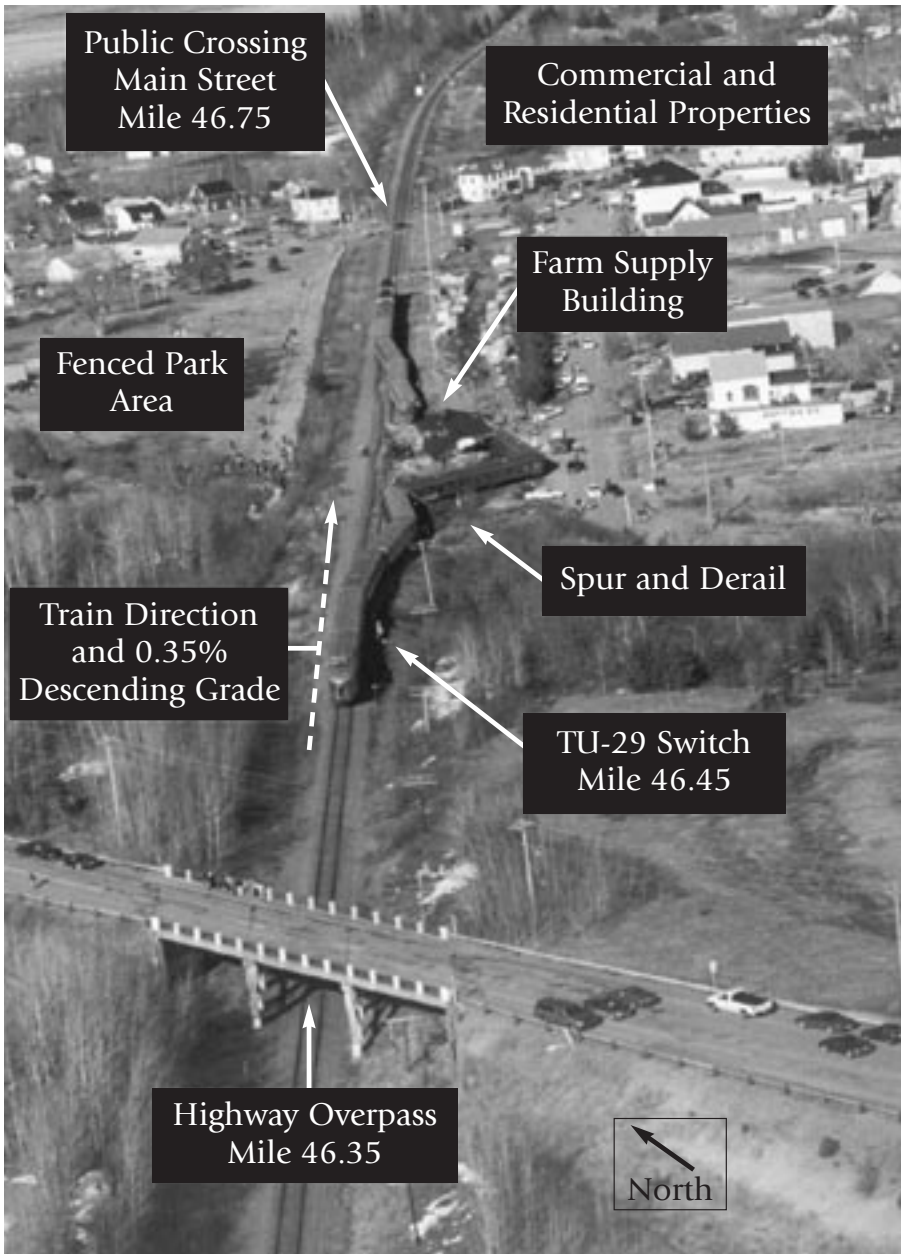
Aerial view of the occurrence site as viewed in the direction of train travel.

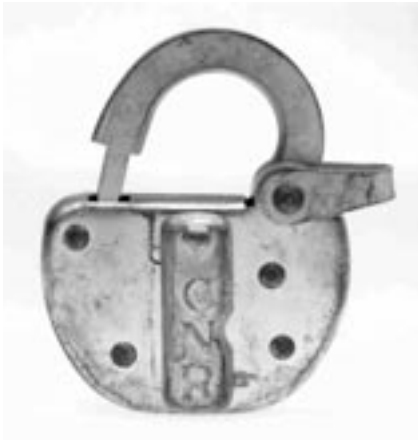
New standard switch lock.

Following this accident, CN and Canadian Pacific Railway reviewed their policies and practices regarding installation of high-security switch locks. As a result, several thousand high-security switch locks were installed on all manually operated main-track switches for signalled and non-signalled territories. Priority was given to those locations with passenger train operations

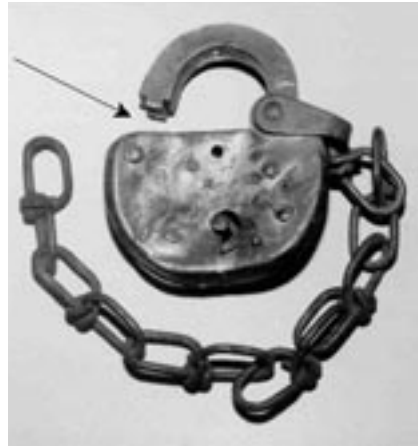
The direct cause of the accident was not a matter of dispute, because the damages to the switch lock and its chain were a clear indication that the switch was unsecured due to tampering. The standard 31B model switch stand was equipped with a standard CN switch lock. The clasp mechanism was broken and the switch lock was hanging loosely, suspended by a chain that affixes the lock to the switch stand. The lock had numerous dents and deformations. A Royal Canadian

Damaged switch lock. Note broken clasp mechanism (arrow).

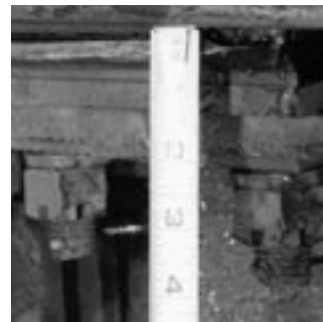
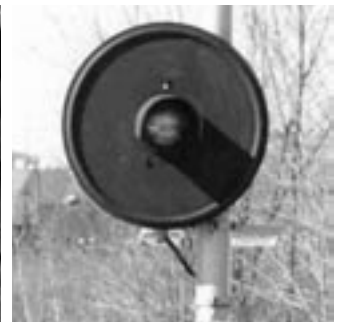
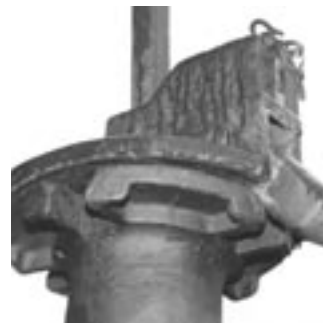
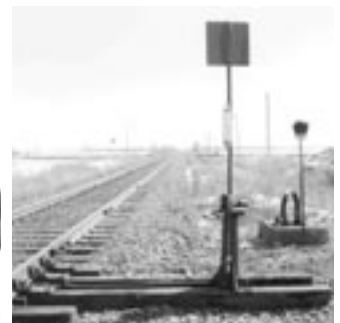
When the security of a switch has been compromised, but the points have not moved 1/4 inch or more, the railway signal system continues to indicate that the switch condi-

Operating crews need information that reflects the actual switch conditions they will encounter. Neither the signals system nor the switch target was capable of providing the crew of Via 15 with information that the TU-29 switch was not properly lined and securely locked. As a result, the approaching train did not receive an advance warning on the change of the switch position.

Top photographs show switch points open 3/16 inch, yet a green CTC signal is displayed to a train crew. Bottom photographs show an unlocked and partially raised switch handle, yet a green switch target.

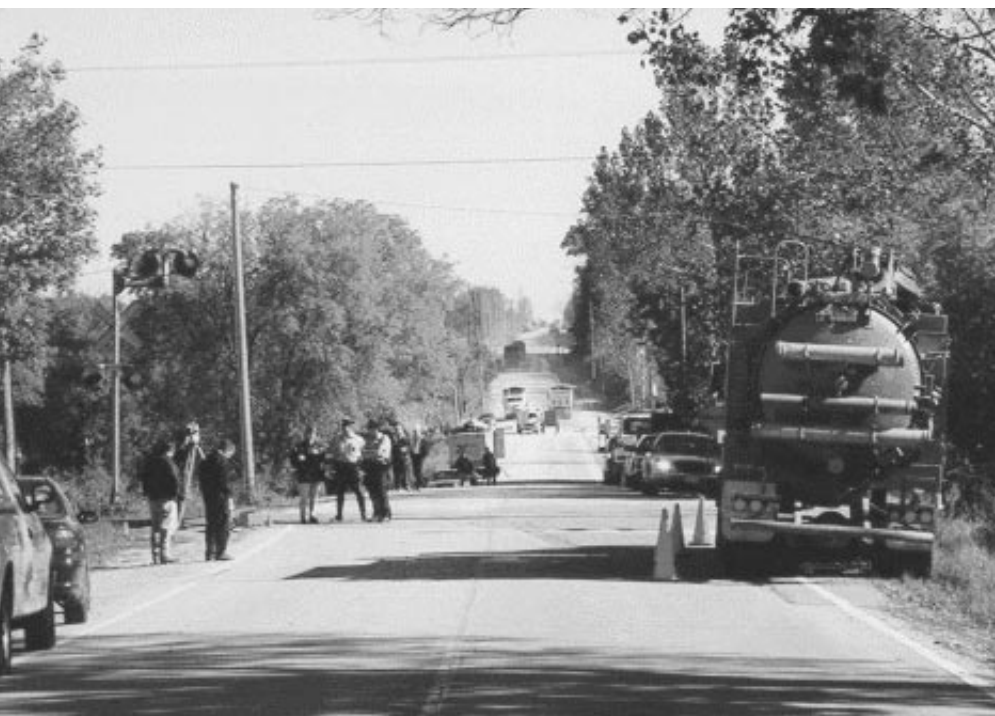
Location of Ontario Excavac Inc. truck, looking southward.

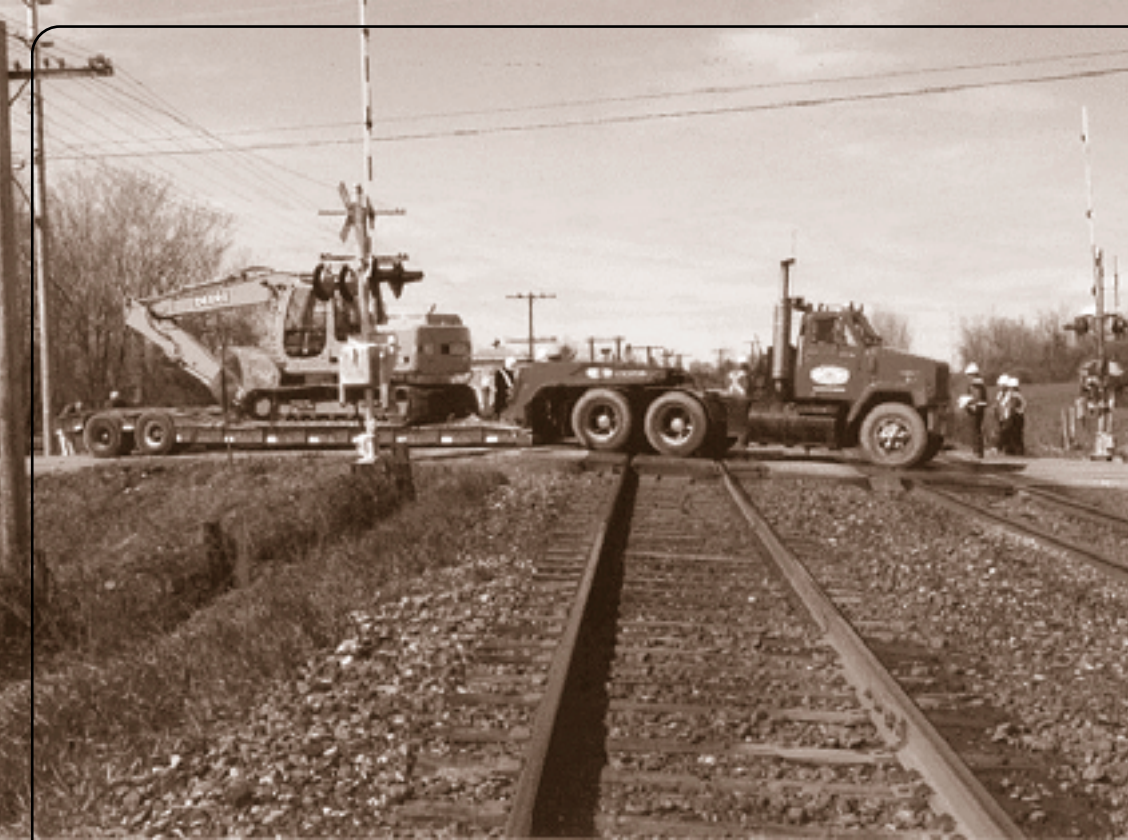
Simulation of truck crossing the tracks at point of grounding-out.

The hump is such that over a horizontal distance of 60 feet (18.29 m), crossing elevation drops approximately 30 inches (76 cm). Road signage on the north and south approaches consisted of a railway crossing advance warning sign, depicting a single set of railway tracks. A pictorial bump warning sign was installed on the same signpost. There was another bump sign immediately before the crossing. However, there was no signage restricting truck traffic or advising of the hazards the crossing might pose to low-ground-clearance vehicles.

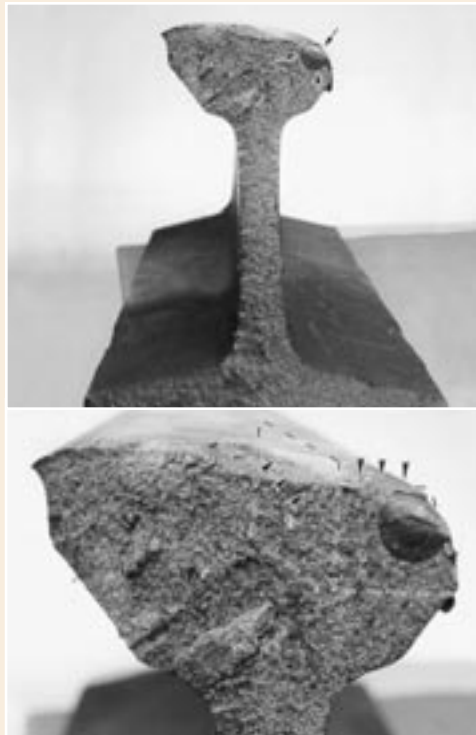
When the double-shoulder tie plates were installed and the rail cant was reduced, contact stresses from wheel loading shifted onto the gauge side of the rail, accelerating the propagation of surface cracks. Further development of these cracks, and the excessive rail head wear, reduced the ability of the rail section to resist crack growth. Subsequently, surface cracks formed subsurface cracks that turned downward and developed into two transverse defects. Rail failure occurred when one of these transverse defects reached a critical size.

Although the two transverse defects represented up to 5% of the total rail head fracture surface, they were likely smaller when the rail flaw detector car carried out ultrasonic and induction tests 46 days before the accident. Reliability of the testing equipment to detect small internal defects is reduced when surface defects are present. Surface defects were present on the rail in 1998 when a grinding program was

Transverse defect representing 5% of the rail fracture surface area.

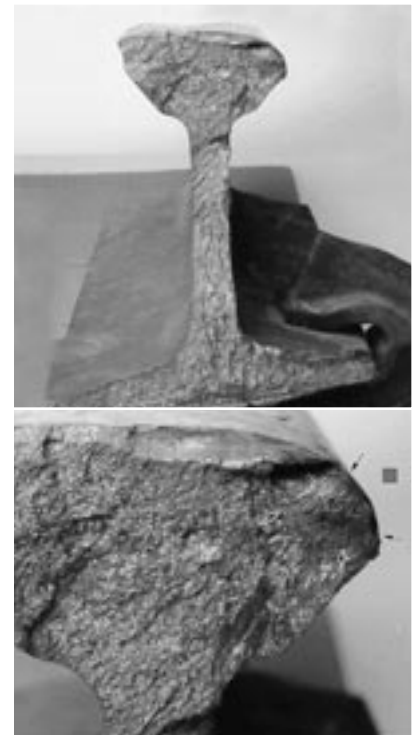
Transverse defect representing 3% of the rail fracture surface area.

scheduled (grinding of the Carmangay turnout was not performed due to a potentially extreme fire hazard) and had propagated since then. When the rail flaw detector car tested the track in 2002, surface defects concealed the presence of transverse defects. In the absence of a grinding program, surface defects are not corrected and reduce the ability of a rail flaw detector car to detect internal rail defects. Canadian Pacific Railway completed the grinding of all the main-track switches on the Aldersyde Subdivision in May 2002.

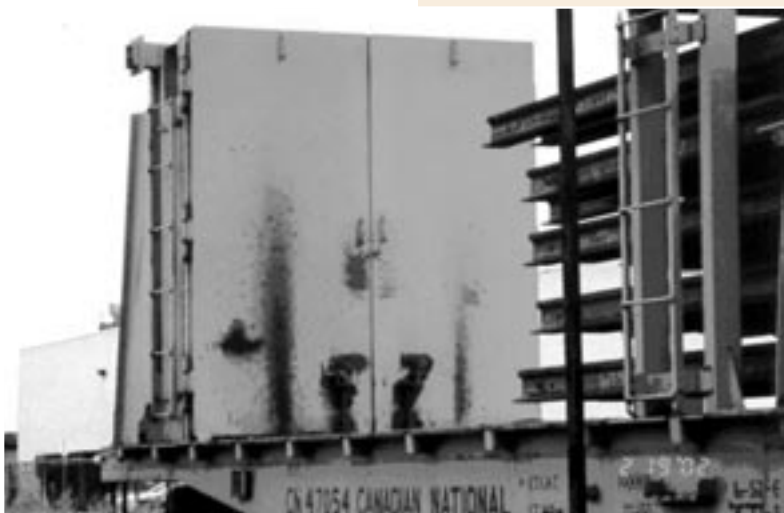
The door had been supported by three hinges. The hinge well areas were shiny and rust free, indicating that they had recently been torn off. The door locking device consisted of two brackets welded to the door face with a pin that slides through the brackets into the car floor.

End doors.

TC stated that CN has now inspected all of its rail transporter cars and completed a program to repair and modify the locking pin mechanisms. CN has also reiterated its loading and unloading inspection program for these cars to their mechanical inspectors and advised them to pay particular attention to the door locking mechanisms and doorstops.

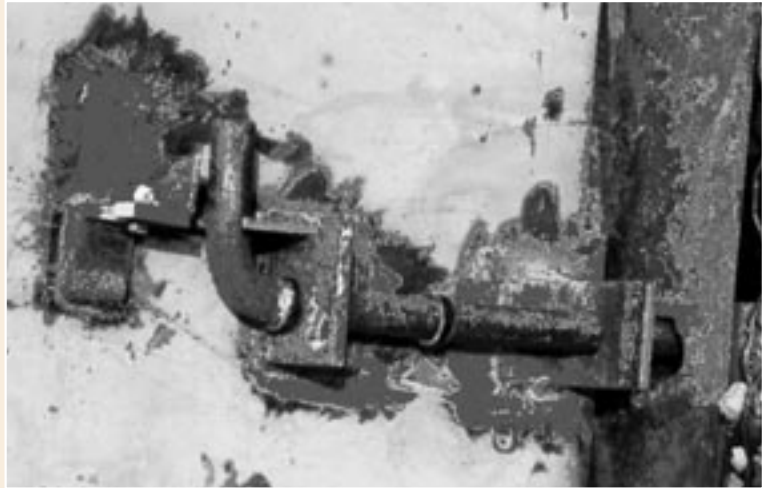
The door brackets and the locking pin were missing and the weldment areas for the brackets were rust covered. It was determined that a piece of piping with a small valve attached had been inserted into the car floor in front of the door as a means of securement for an undetermined period of time. This makeshift device was not recovered. The door stop, welded to the side of CN 46570 to restrict door swing, was missing and the weldment area was rust covered.

Locking pin.
